TECHNICAL REPORT

NO. 12777

M60 CLEAN AIR WINTER TEST

Final Report

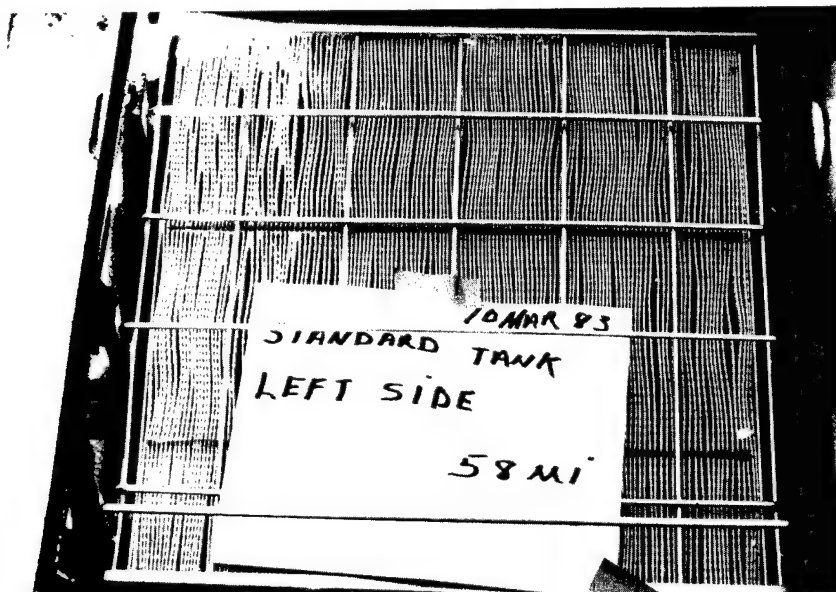
Immediately before beginning operation on 9 March 1983, clean air filter elements were installed in both tanks. The following morning, 10 March, the air box filter covers were lifted and photographs of the "as installed" condition in both vehicles were taken. These are shown in Figures 6 through 9. The filters were then carefully removed, taking care not to disturb any clinging snow, and placed into plastic bags. Next, the filters were weighed within the plastic bags for a gross weight measurement. In all cases, if packed snow was seen, it was packed only at the outlet side. The filter and accumulated snow weights are presented in Table 1.

Figure 6. Standard Tank. Left Side Air Filter Element, After Testing 9 March 1983, on Morning of 10 March.

Figure 7. Standard Tank, Right Side Air Filter Element, After Testing 9 March 1983, on Morning of 10 March.

Figure 8. Clean Air Tank, Left Side Air Filter Element, After Testing 9 March 1983, on Morning of 10 March.

Figure 9. Clean Air Tank, Right Side Air Filter Element, After Testing 9 March 1983, on Morning of 10 March.

<u>Standard (ACBM)</u>		<u>Clean Air (VEDES)</u>	
	<u>Left</u>	<u>Right</u>	<u>Left</u>	<u>Right</u>
Gross	24 lb 14-1/8 oz	22 lb 14-1/4 oz	32 lb 14-3/8 oz	31 lb 12-15/16 oz
Tare	<u>2-3/4</u>	<u>2-3/4</u>	<u>2-3/4</u>	<u>2-3/4</u>
Net	24 lb 11-3/8 oz	22 lb 11-1/2 oz	32 lb 11-3/5 oz	31 lb 10-3/16 oz
Orig Weight	<u>21 lb 14-15/16 oz</u>	<u>21 lb 15-1/8 oz</u>	<u>30 lb 5.0 oz</u>	<u>30 lb 13-3/16 oz</u>
Diff	2 lb 12-7/16 oz	12-3/8 oz	2 ob 6-5/8 oz	13.0 oz
